**De-silting of the moat at Haughley Castle,
Haughley
HGH 046**

Archaeological Monitoring Report

SCCAS Report No. 2012/127

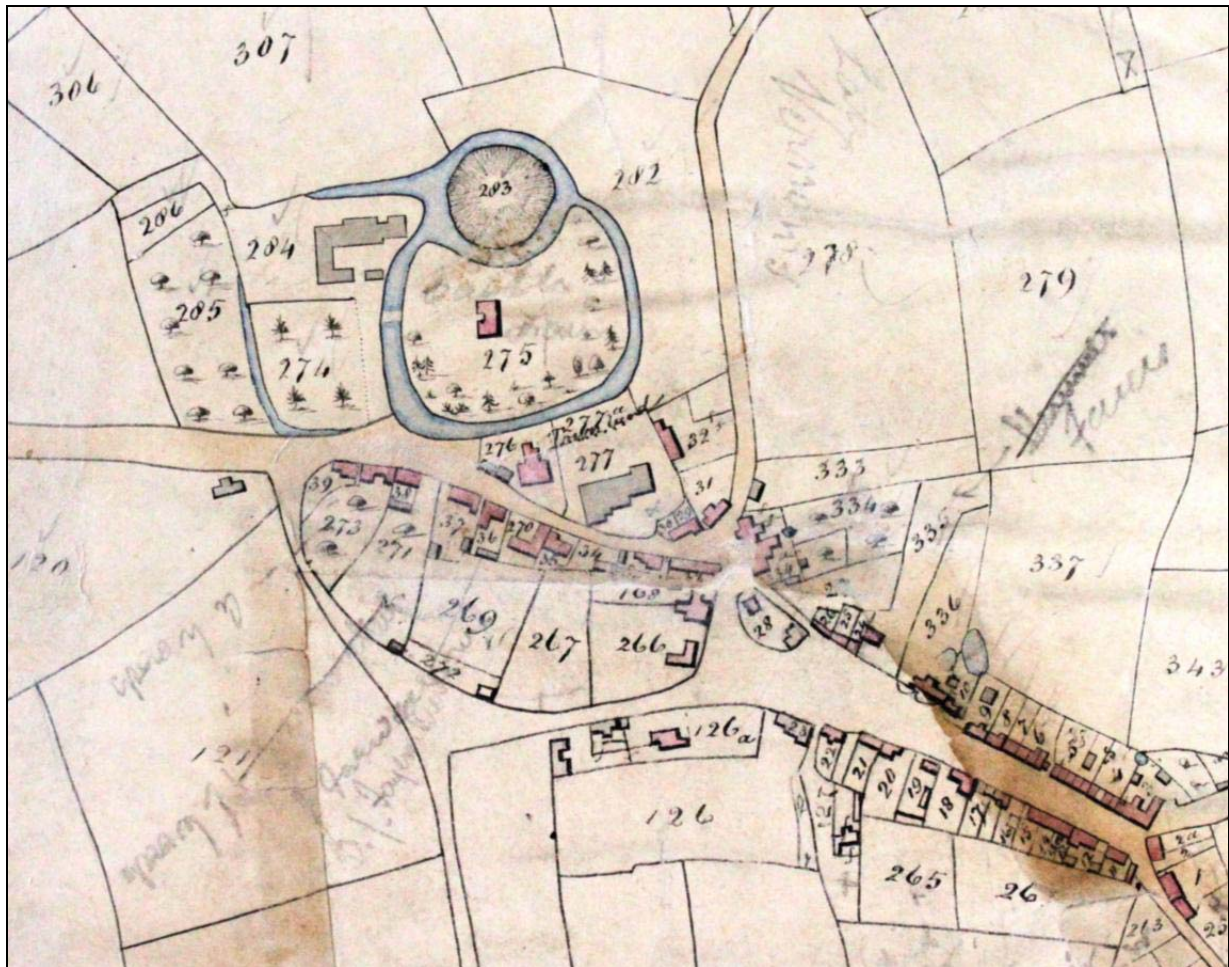
Figure 2. Haughley village as depicted on the parish tithe map of 1845 (SROI). The loop to the south of the present moated motte and bailey must represent either an additional outer bailey or market infill.

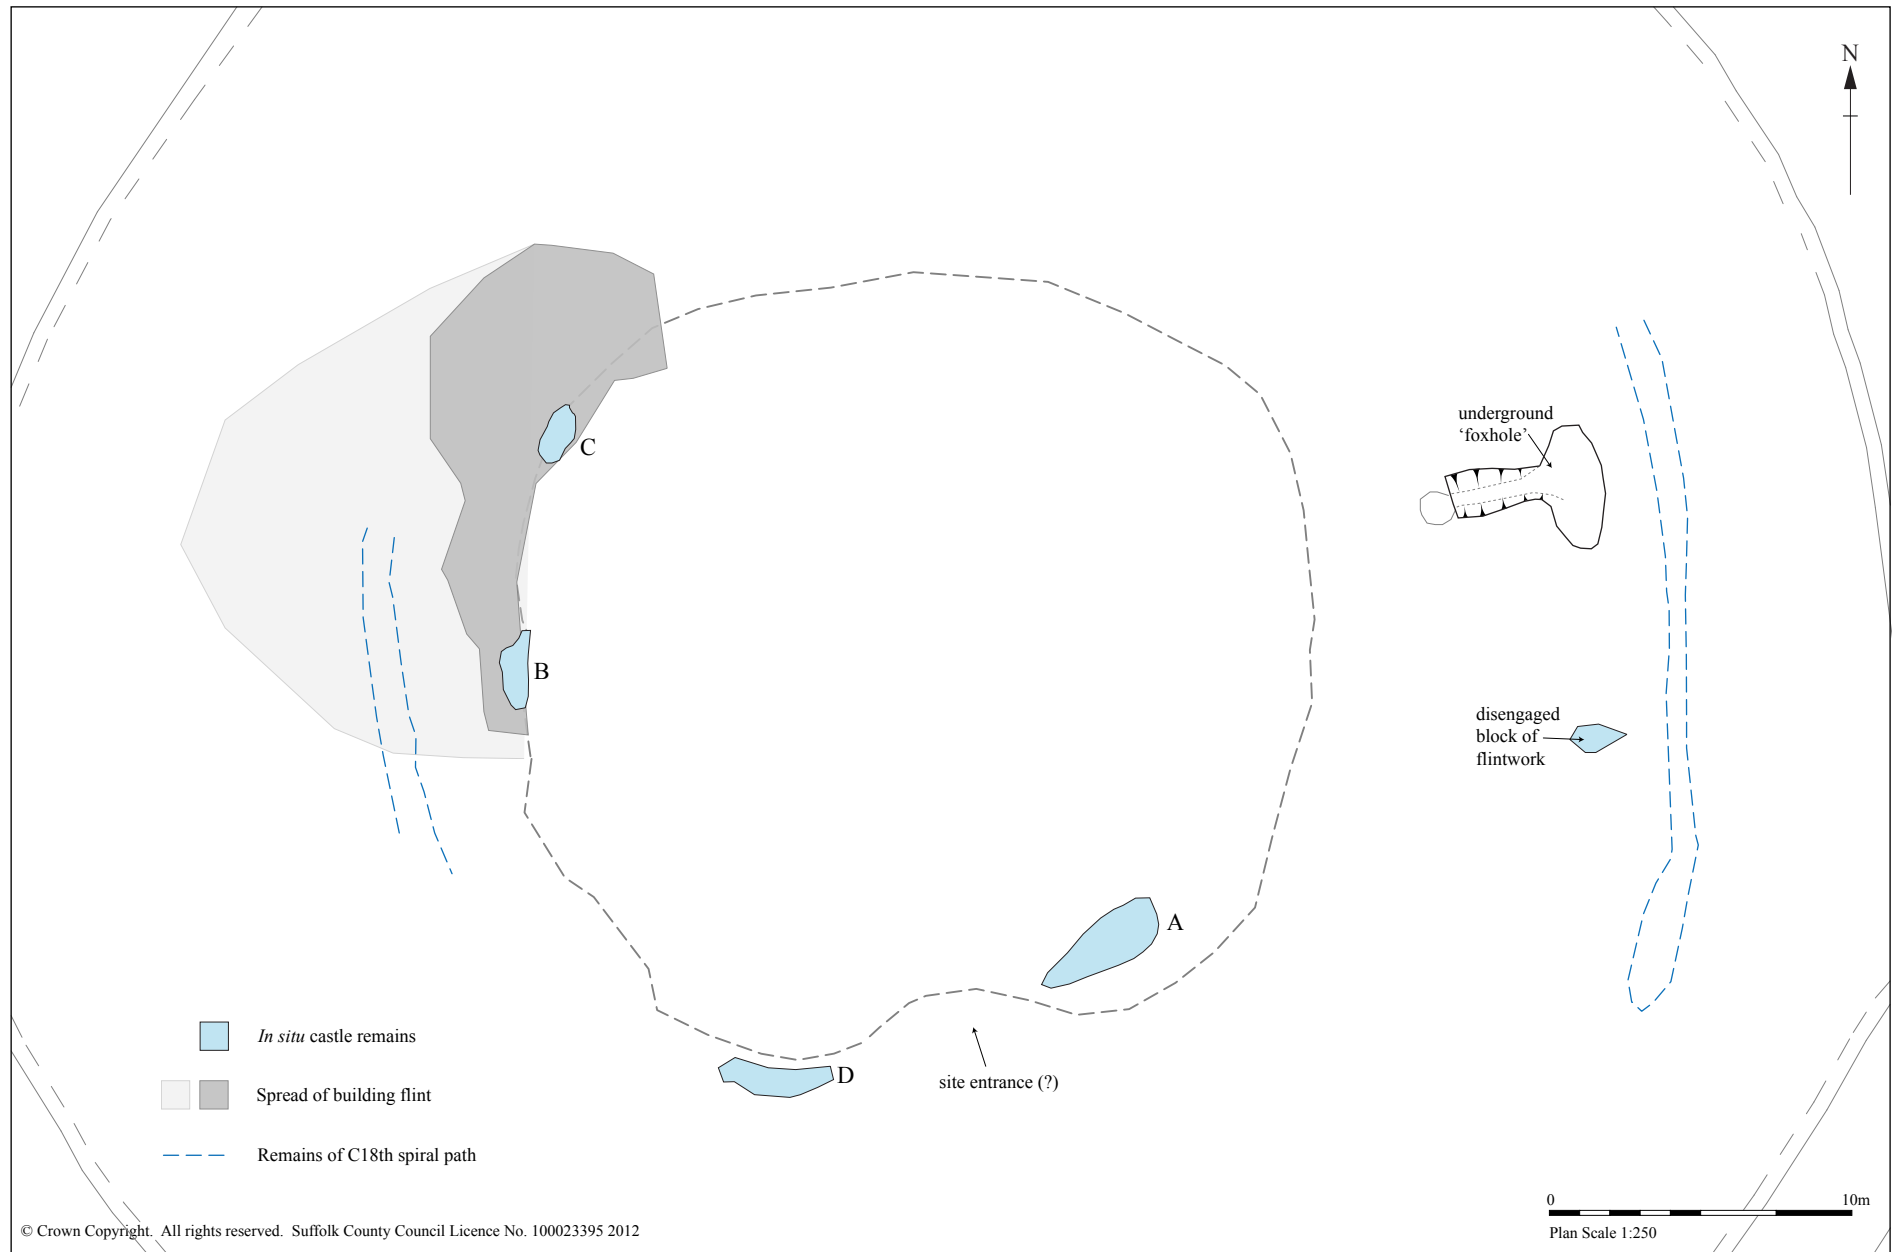
Figure 4. Plan of the Motte platform showing *in-situ* bonded flint remains of the stone keep and post medieval & modern earth works.

Other earthwork features on the motte included evidence of the post-medieval spiral path which was still just visible as a shallow lip on the east and west sides, but the route has all but vanished on the north and south sides (Fig. 4).

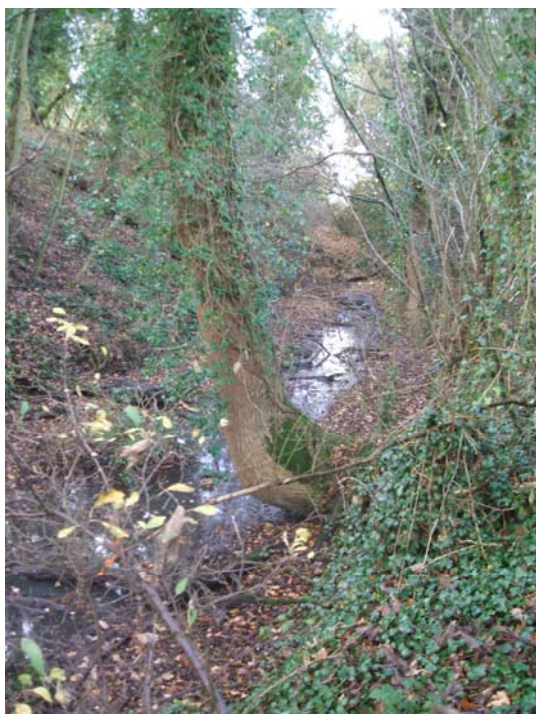
Plate 1. Bailey moat, choked and overgrown, on the east side of the castle facing north prior to the start of work

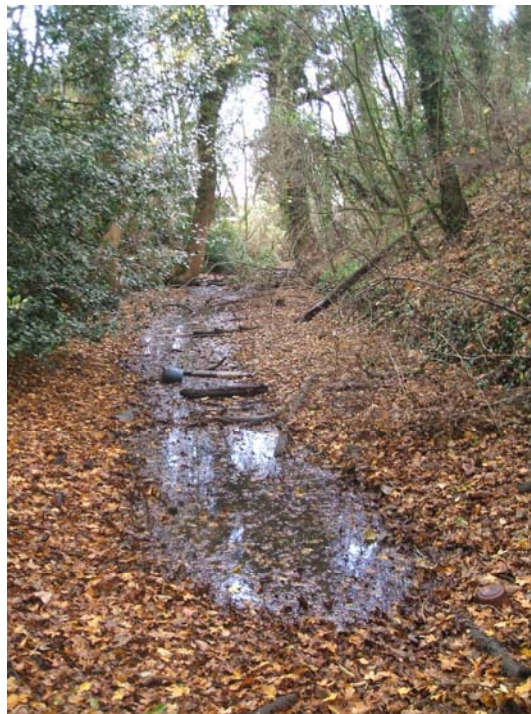
Plate 2. Infilled moat on the east side of the motte facing south

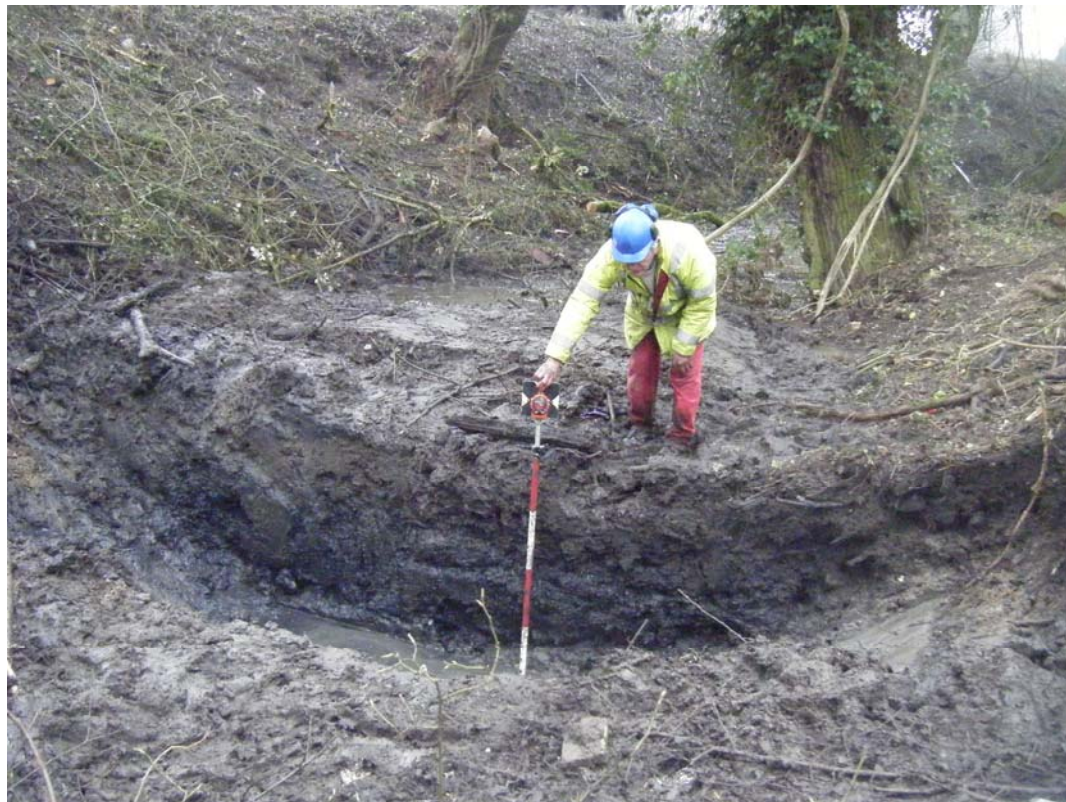
The section shows the moat to be filled in two distinct phases, the upper fills made up of accumulated organic material and the lower a dense clay-silt which was devoid of organic matter (Pls.3 and 4). Separating the two was a layer of stone and flint, building material that had tumbled in a scree from the top of the motte. The upper silts survived in different states of decay, the lower silts being made up of a dense mat of coarse twiggy roundwood and leaf-mould that had been laid down in water and sealed quickly by later deposits to create anaerobic condition in which the organic material did not breakdown. In contrast to this the uppermost silts although originally composed from the same of material had be subject to a changeable wet-dry environment and had decayed to a fine, uniform mud.

Plate 3. Evaluation trench1 on the north side of the motte, showing depth of modern organic silts forming the upper deposits of the moat infill. The survey staff rests on the top of the primary silt made up of pale grey clay which can be seen on the sides of the cut and at water level

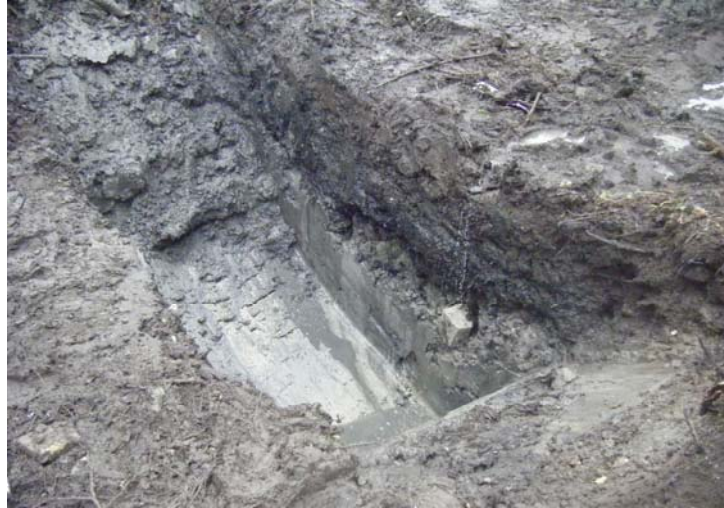
Plate 4. Evaluation trench 1 on the north side of the motte showing grey clay primary silt removed from the centre of the moat and the base of the ditch cut. A single block of Barnack building stone from the castle keep remains in the section and the position of further stones, which fell out before the photograph could be taken, can be seen as the indented area between the black and grey silts. The section depth is 2.6m

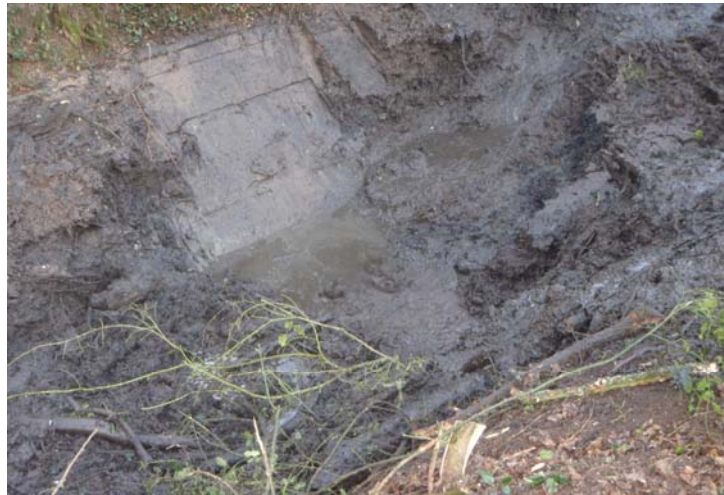
Plate 5. Attempted section through moat on the east side of the bailey. The water-logged silts were unable to hold a section and bailey ditch was recorded in profile once emptied and by snapshot. The moat was machined to brown primary silts which can be seen on the far side of the ditch.

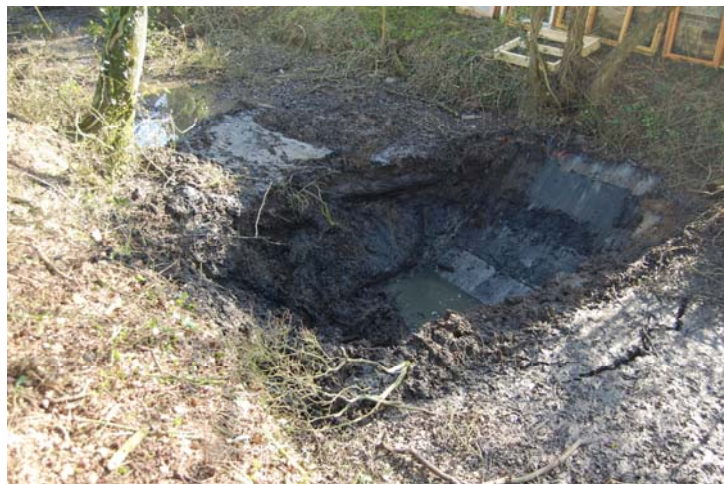
The exploratory section across the north arm of the western enclosure ditch, Section 7 (Figs. 3 and 6 and Pl.6), showed that the ditch had been cleaned out in the relatively recent past. Milk bottles, pan-tiles and bricks, which matched those used on the adjacent (refurbished) barn, were found close to the bottom and the existing ditch shape reflected the arc of the machine 'pull', suggesting that the previous dredging was also mechanical. The exposed natural – which was not seen in the other excavations - was blue boulder clay. The ground level was 56.85m and the bottom of the ditch 52.99m. Because of its recent history the ditch was re-cleaned to natural from Section 7 eastward to the motte's moat edge.

Plate 6. Evaluation Trench across the north arm of the western enclosure ditch (section 7), which had been cleaned out in the recent past and black silts and modern deposits were seen at the section base. Total depth 1.45m

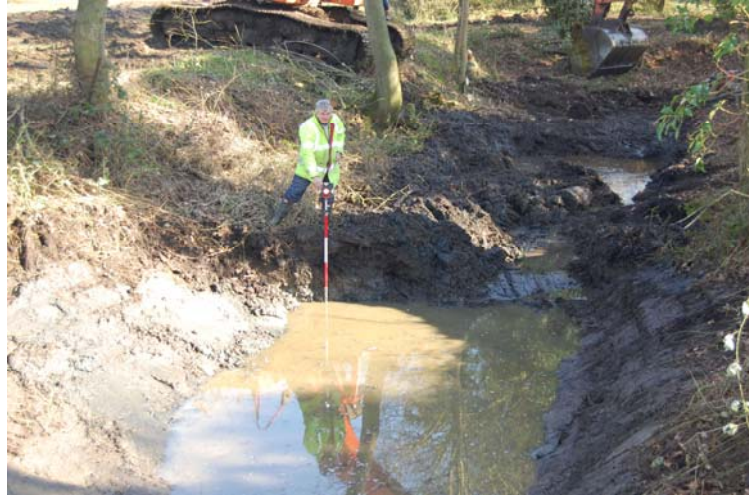
The long rectilinear fishpond at the north of the monument was cleared of layers of black silts and a thick accumulation of leaf-mould (PI. 7). The fishpond had been used as a rubbish tip in the relatively recent past (since WWII) and the upper silts were packed with bottles, enamelled tin ware, china, tins and bits of bicycles and other rubbish to a depth of c.0.7m. Up to 1.1m depth of material was removed and recorded in Sections 5 and 6 (Figs. 3 and 6). At the east end this exposed an underlying layer of brown clay, a (?)primary silting layer built up during the life of the pond. This material appeared archaeologically sterile and could not be dated, but was thought to be 'old'. It was left in place and the full depth of the fishpond at the east end was not exposed.

Plate 7. Excavation of the east end of the fishpond (Section 5) during the removal of C20th deposits; brown clay primary silt at the base of the pond has been left in place.

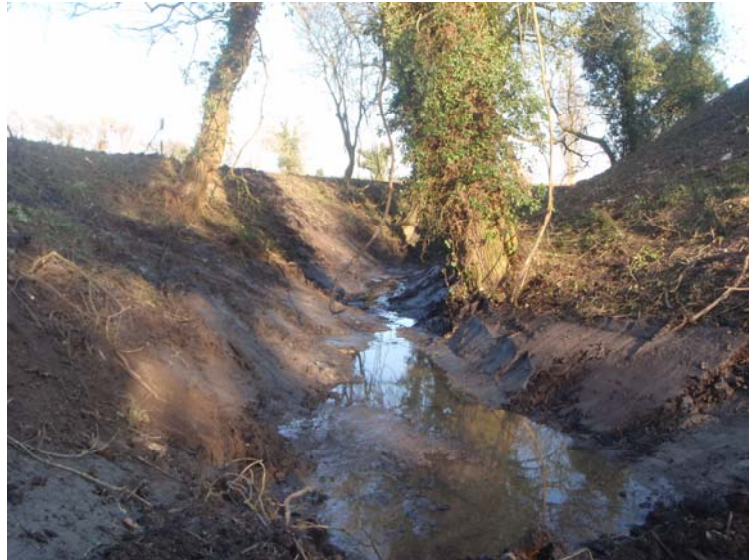
Plate 8. Motte ditch on the north-east side looking south-east after the removal of the later silts. The limit of the excavations were inside the original cut of the moat ditch in order to preserve evidence of its shape

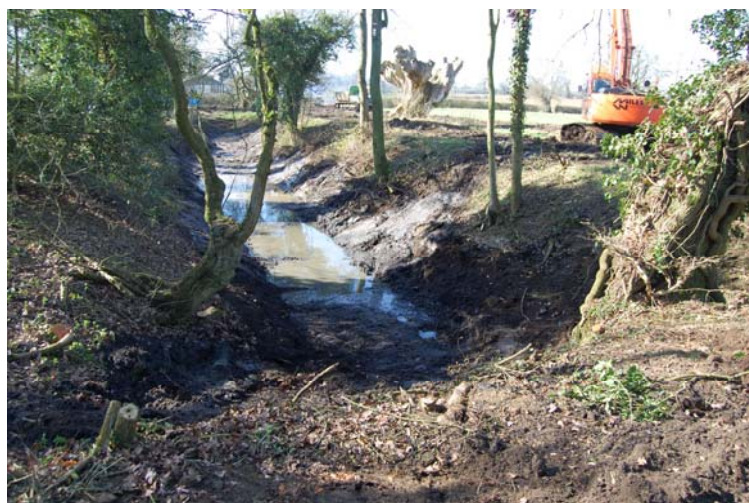
Plate 9. Linear fishpond to the north of the castle after cleaning out, looking west

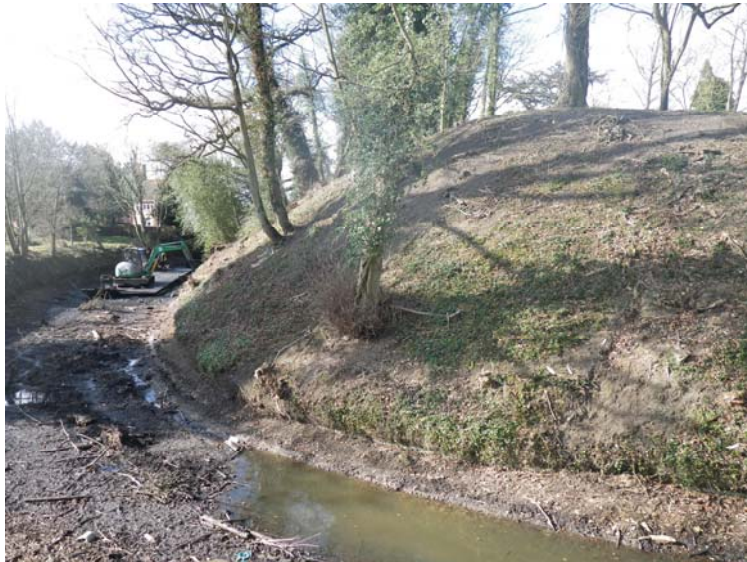
Plate 10. SE corner of the bailey bank and moat facing west. Note how the water action has eroded a channel at the base of the bank which was exposed when the water level was reduced

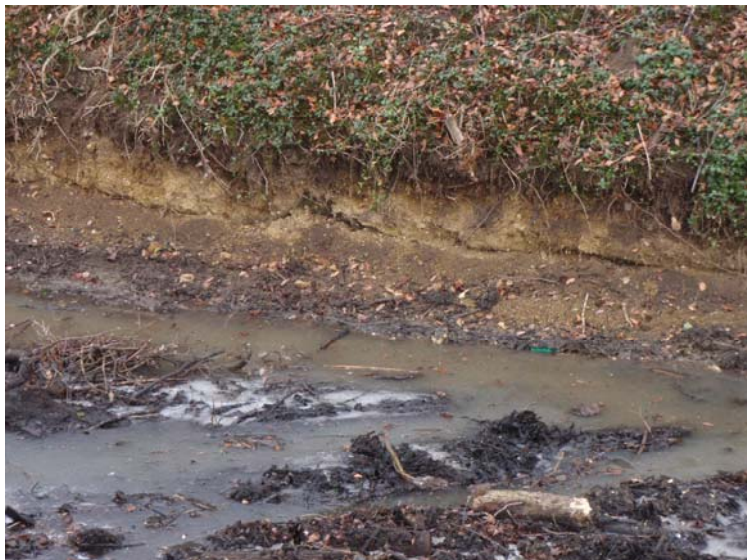
Plate 11. Detail of the depth of erosion at the base of the bailey bank, south side. This level is below the pre-castle ground level ground and the yellow clay silts of surface geological formation are exposed

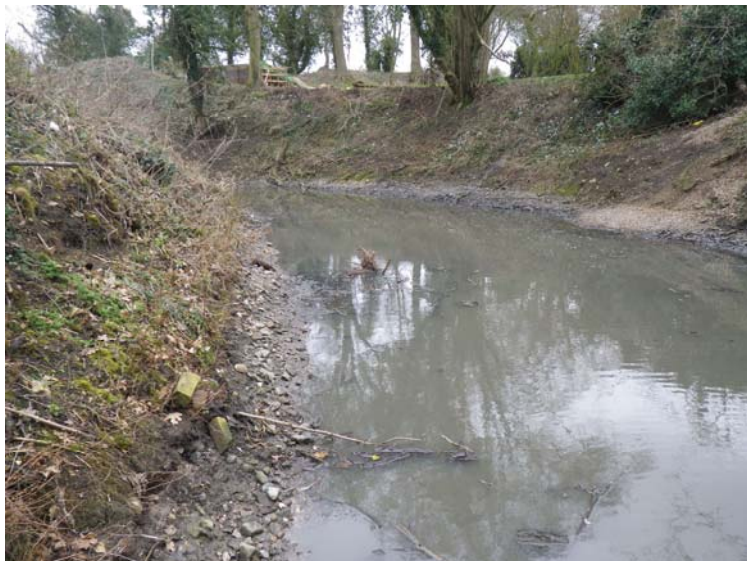
Plate 12. Scree of loose flints from the former castle keep at the motte base, south side (left) facing SE

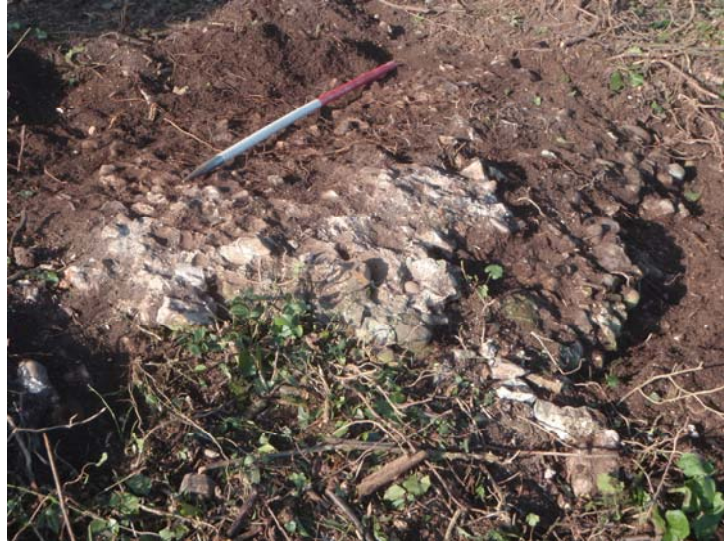
Plate 13. Bonded flint (Area B) *in-situ* remains of the keep foundations on the edge of the motte platform, facing east.

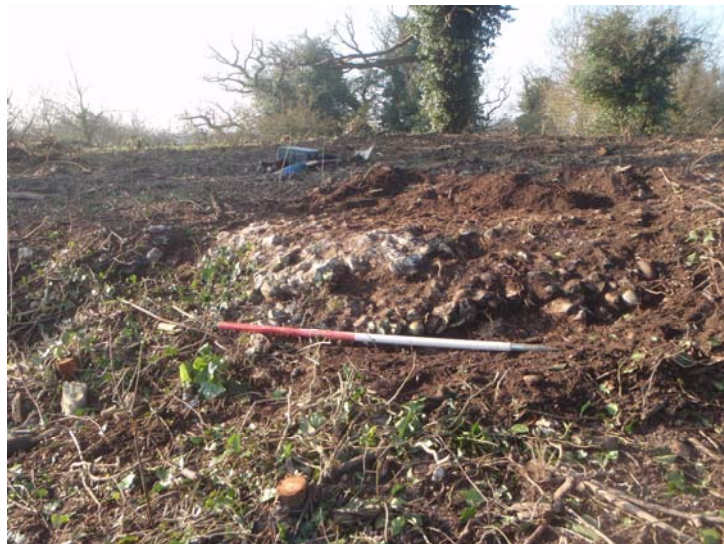
Plate 14. *in-situ* remains of the keep foundations on the edge of the motte platform (Area A0 facing N).

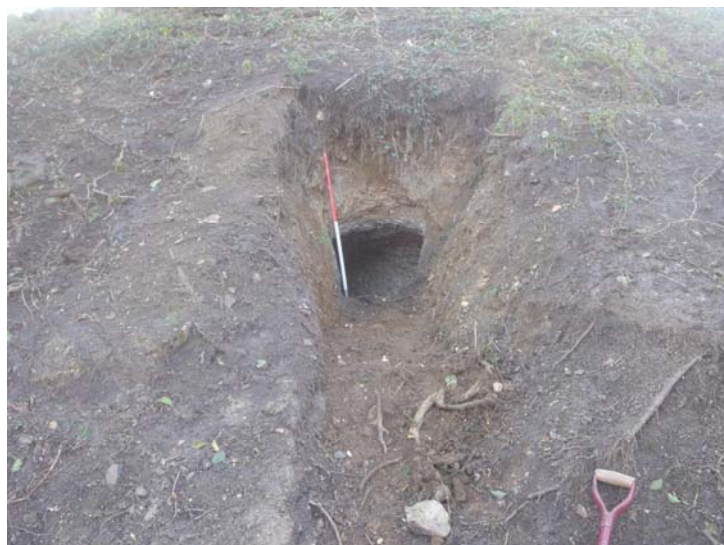
A large 'foxhole', a below ground chamber with an entrance 1.5m high, has been excavated into the east side of the motte about half way up. It is thought to be the work of local teenagers, who have burrowed 2m into the core of the mound; it contained modern rubbish and the remains of a fire. The excavations show the composition of the upper layers of the mound which is made up of topsoil over brown clay over chalky blue boulder clay (PI 15); a sequence that was the same natural geological stratigraphy.

Plate 15. Modern, man-made, 'foxhole' burrowed into the east side of the motte at mid-height. The hole is accessed by a cutting excavated into the side of the mound and the hole extends 1-1.5m into its core

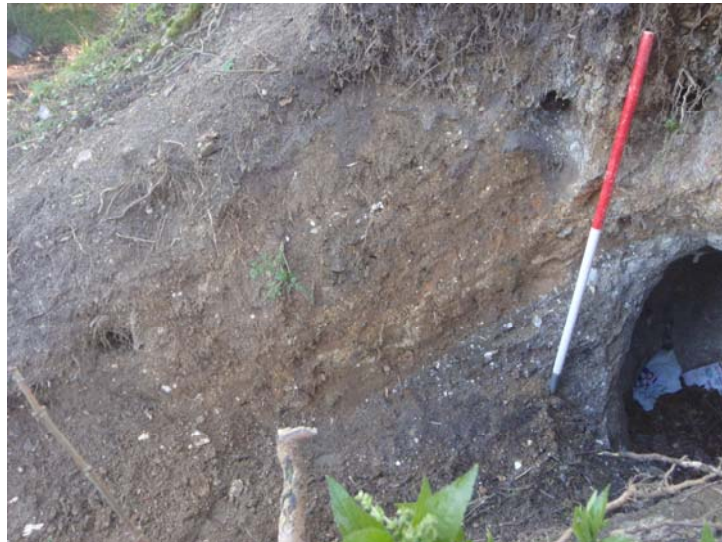
Plate 16. Section of the approach to the 'foxhole' showing soil profile and make up of the mound. The core of the mound is grey clay, similar to the underlying geological formation and excavated from the bottom of the ditches whilst the surface is composed of brown clay similar to that found nearer the surface. There is a sharp cut off between these layers suggesting the deposition of these clays were separate events

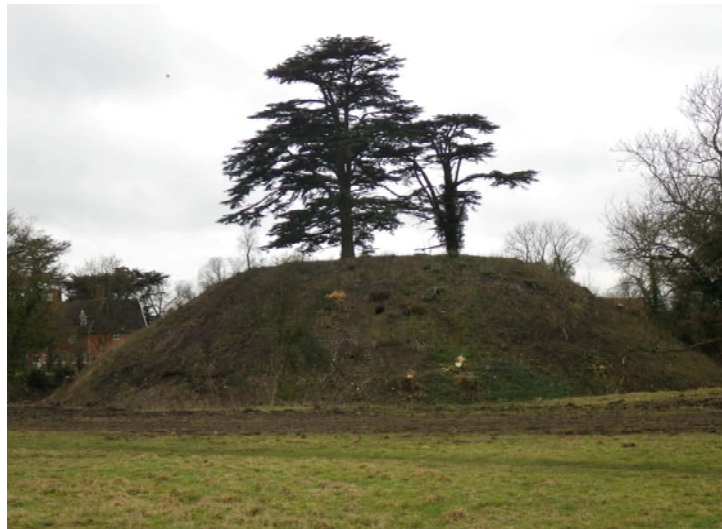
Plate 17. NE side of the motte after tree removal. The man-made foxhole can be seen at mid-height, centre.

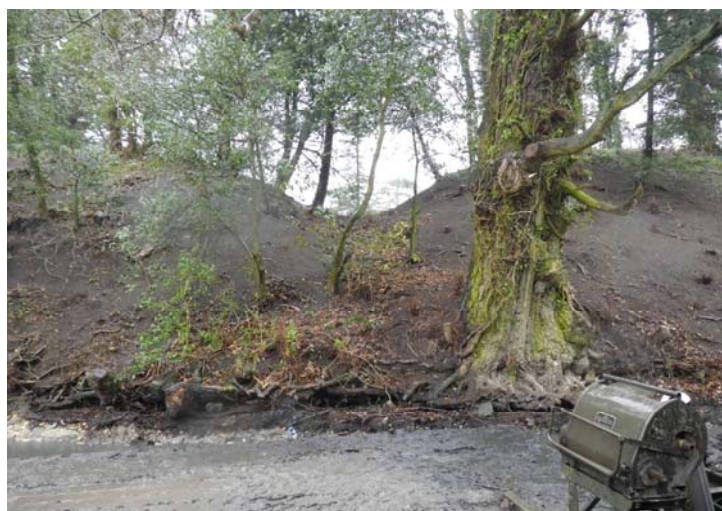
Plate 18. 'Saddle' in the bailey bank at the south cardinal point, facing N, the castle's probable former entrance

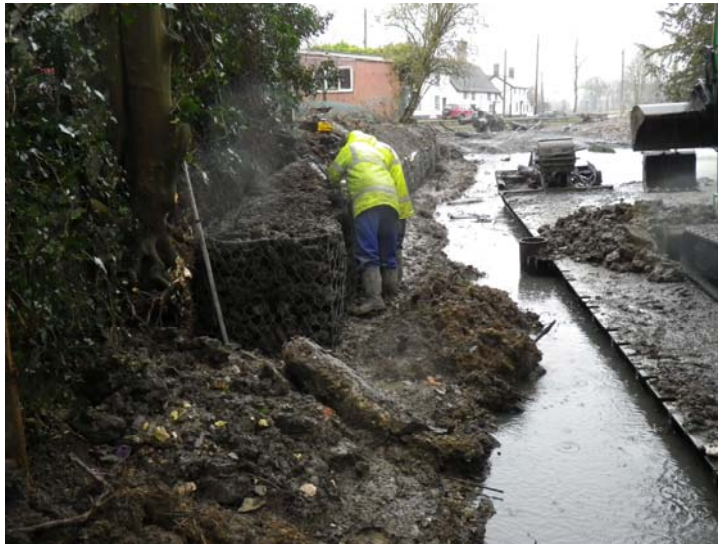
Plate 19. Building of the gabion wall on the south side of the bailey moat, facing west. The ledge is cut into moat infill deposited in the 18th century

The garden of 'The Grange' encroached on the moat's south edge and was supported by a collapsing revetment made of concrete and timber. As part of the scheduled work the revetment was removed and replaced with stone-filled gabions which ran the whole length of the property from the east end of the fishpond to the east edge of The Grange's plot. The machine cut a vertical step into the bank excavating down 1.5m from garden level along the line of the boundary fence to form a horizontal shelf on which the gabions were set (S8, Fig. 6). The vertical cut was 2.20m back from the water's edge, the point at which the cut of the moat ditch dropped steeply away. To create the ledge the machines cut through made-up ground comprising redeposited pale-brown boulder clay which sealed a black mud deposits (layer 0100). The mud layer produced a large assemblage of domestic waste (mainly decorated china, clay pipes, animal bone and oyster-shell), and building material (bricks, tile, building timber, and a thatching spar); amongst the finds was a gravestone dated 1737. The top 300mm of this deposit was removed but a considerable depth was left intact and this layer was seen along the complete length of the excavations. The presence of this infill demonstrates that the ground levels here are built on moat infill (deposited since 1737) and suggests that the original edge of the moat was further to the south. The current ditch profile (prior to this *tranche* of work) cuts through the infills and is therefore a re-cut and demonstrates that the moat has been cleaned out before.

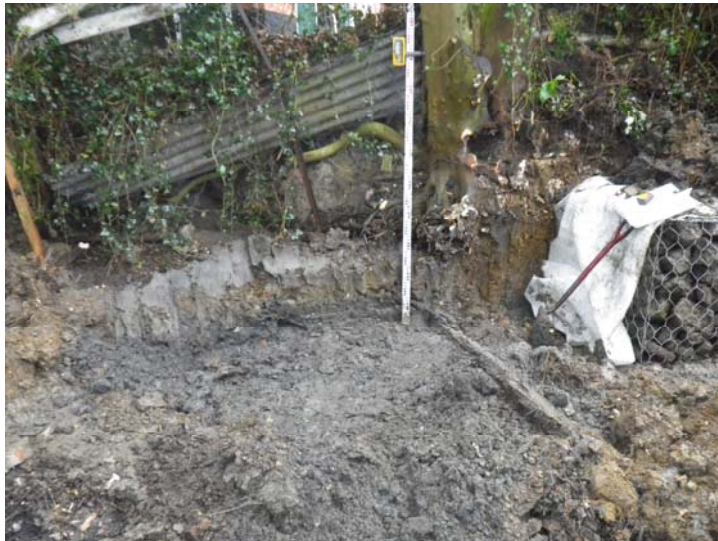
Plate 20. Black infill silts dating to the C18th below redeposited yellow clay on the south side of the bailey moat, facing south. The Norman cut of the moat ditch is further back, behind the make-shift fence

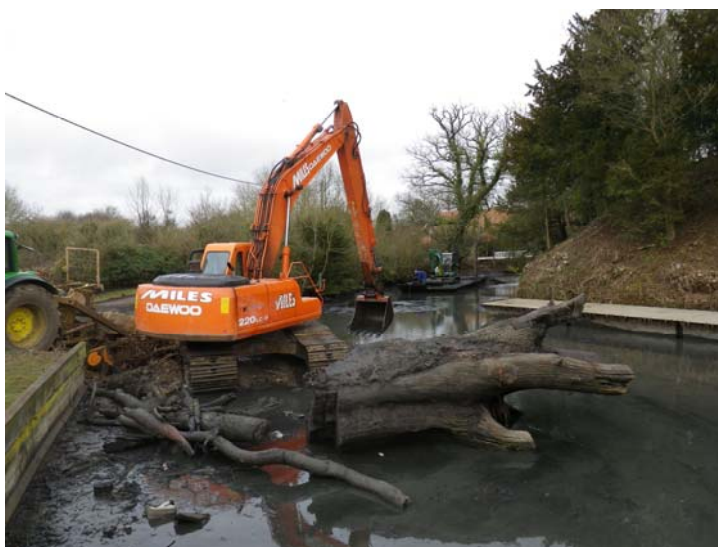
Plate 21. Land-based and barge-mounted excavators clearing the bailey ditch and duck pond viewed from the south

The first stage of de-silting was completed by a long-reach machine working from the bank and removed moat silts from the north and east side of the motte and the east side of the bailey, the north side of the western enclosure ditch and the fishpond (Fig 3.) The machine working under the guidance of the monitoring archaeologist removed only the recently accumulated upper organic silt layers as established by the evaluation. The base of this deposit was left in, as a protective buffer to the underlying clay silts, and a leeway given the sides of the ditch to ensure they were not damaged (Pl.8). The fill of the moat was consistent with those layers seen in the sections for the complete circuit between S1 and S2. The material removed was all relatively recent and therefore no

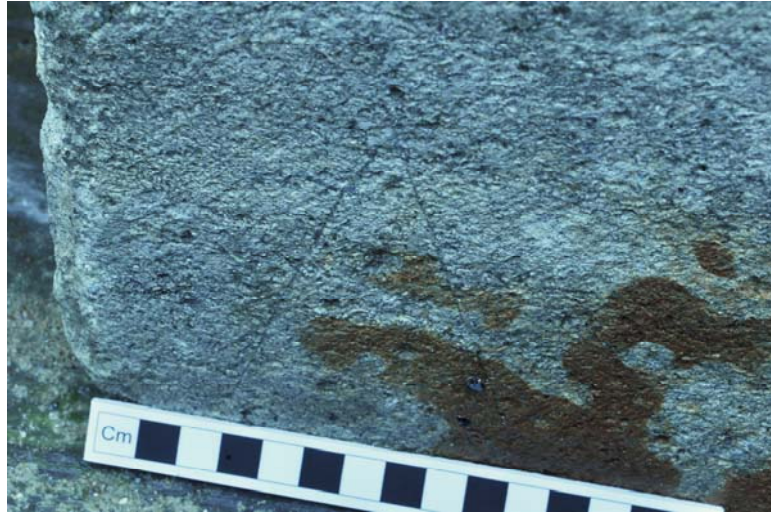
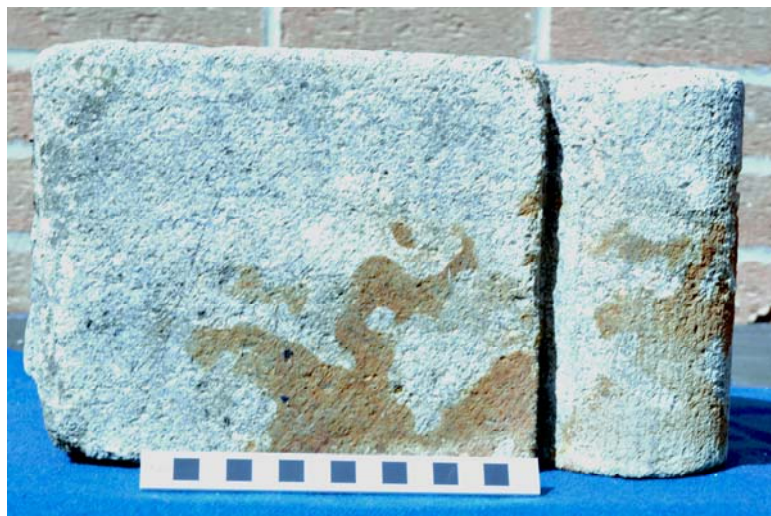
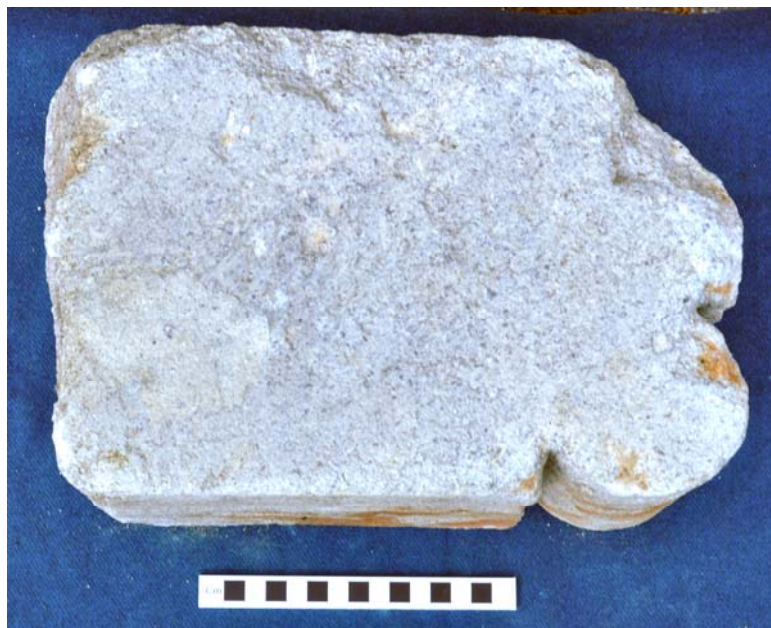
The stone was a Barnack-type limestone derived from the quarries of south Lincolnshire; they were all a similar size (c.300mm³) and weighed a handable 30-35kg. Most of the stones were cut into plain cubes and exhibited tooling marks on their flat faces with mortar attached to the jointing ones. The faces of the stones were fresh but the corners were chipped and damaged. The corner of one stone included part of an engaged column which would have once framed an opening. The flints were large 'field-flints' which had been selected for size; all were fist-sized or larger and some had lime mortar attached.

Plate 22. Dressed Barnack stone associated with the construction of the castle keep's walls. Showing masons marks (top) and section of engaged column (?) part of a decorated opening (middle and bottom)
